### Report Number: 160510008SHF-BP-1

Sample Description:		
Product:	ECOLEGNO COMPOSITE WOOD	
Model:	DECKING AND WALL CLADDING	
Sample Quantity:	24 pieces	
Sample ID:	S160426011SHF-001~024	
Date Received:	2016/4/25	
Date Test Conducetd:	2016/5/5

This report describes the results of the ASTM E84-15b TEST FOR SURFACE BURNING CHARACTERISTICS OF BUILDING MATERIALS a method for determining the comparative surface burning behavior of building materials. This test is applicable to exposed surfaces, such as ceilings or walls, provided that the material or assembly of materials, by its own structural quality or the manner in which it is tested and intended for use, is capable of supporting itself in position or being supported during the test period.

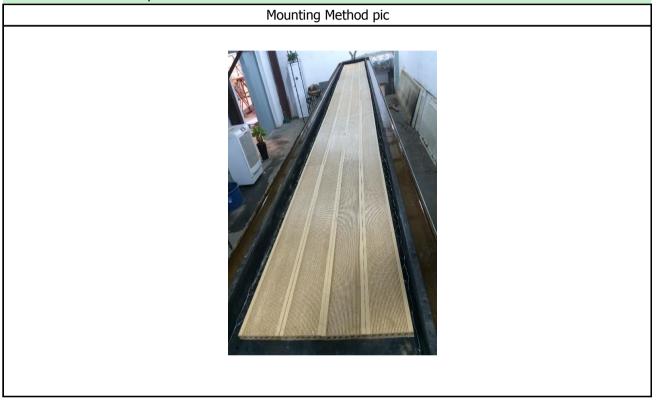
#### **Mounting Method:**

The specimen was supported with 0.25-in. diamerter metal rods that were spaced approximately every two feet and 20-gage, 2-in. hexagonal galvanized steel netting.

The smooth side was exposed to the flames.
